**Archaeological Monitoring  
the Demolition and Dismantling-  
Commemoration Project, Marshall Lime Kilns,  
Upper James and Red Hill Expressway,  
Regional Municipality of Hamilton, Ontario**

Submitted to  
**Regional Municipality of Hamilton-Wentworth  
Hamilton, Ontario**

**ARCHAEOLOGICAL SERVICES INC.**  
662 Bathurst Street  
Toronto, Ontario

December 1994

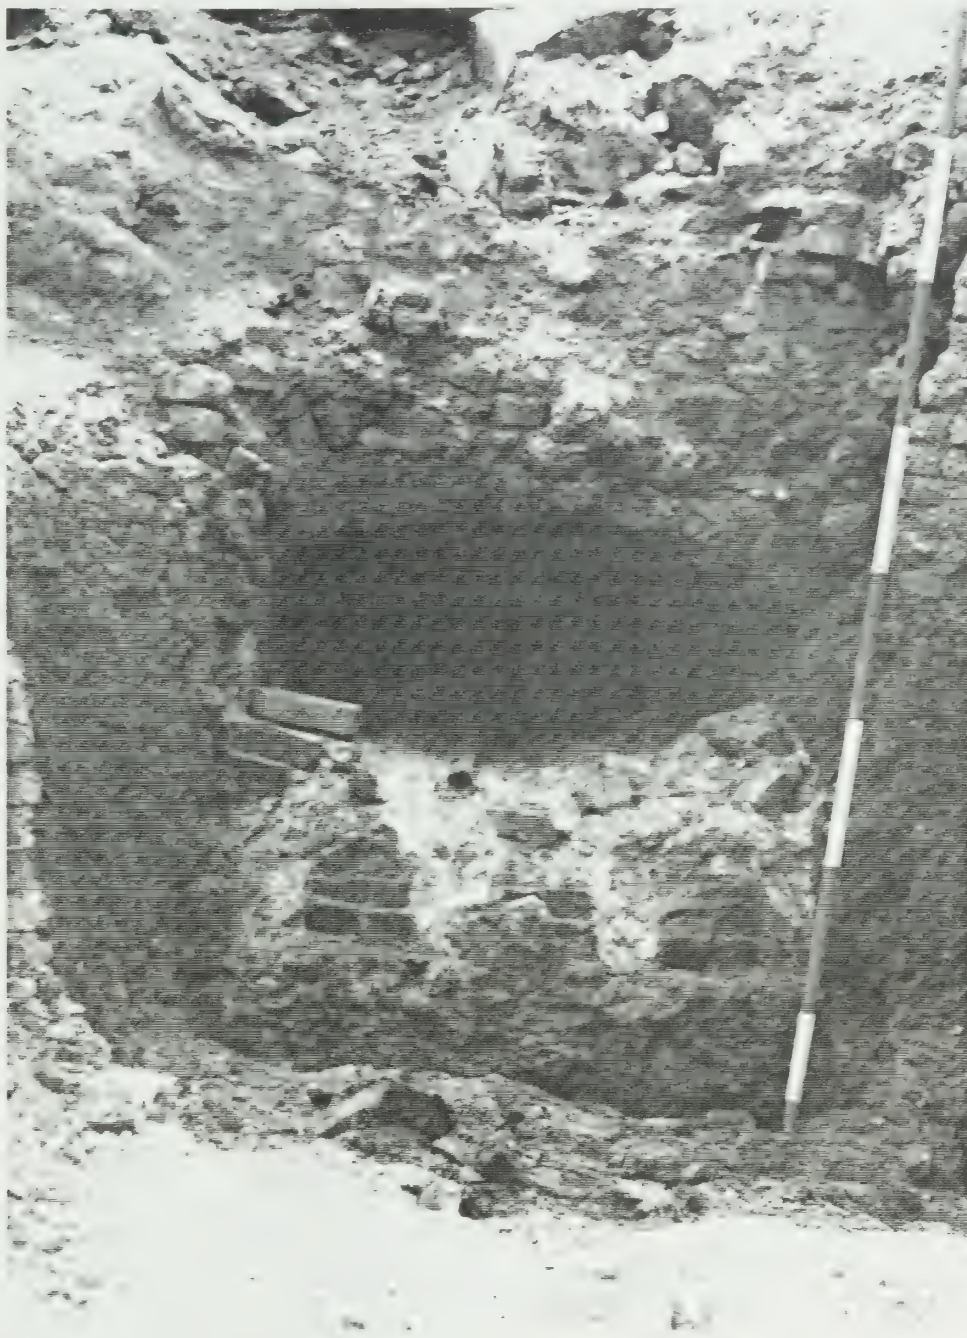
**Plate 18: Kiln One - South Furnace**

South furnace showing the bases of pillars covered with limestone, July 5, 1994. One gas pipe is visible as is one air pipe to the left, near the top of the range rod. The poor condition of the entrance of the firebox into the stack can be seen by the distance back from the range rock marking the location of the stack. The stack was a straight wall at the mouth of the furnace.

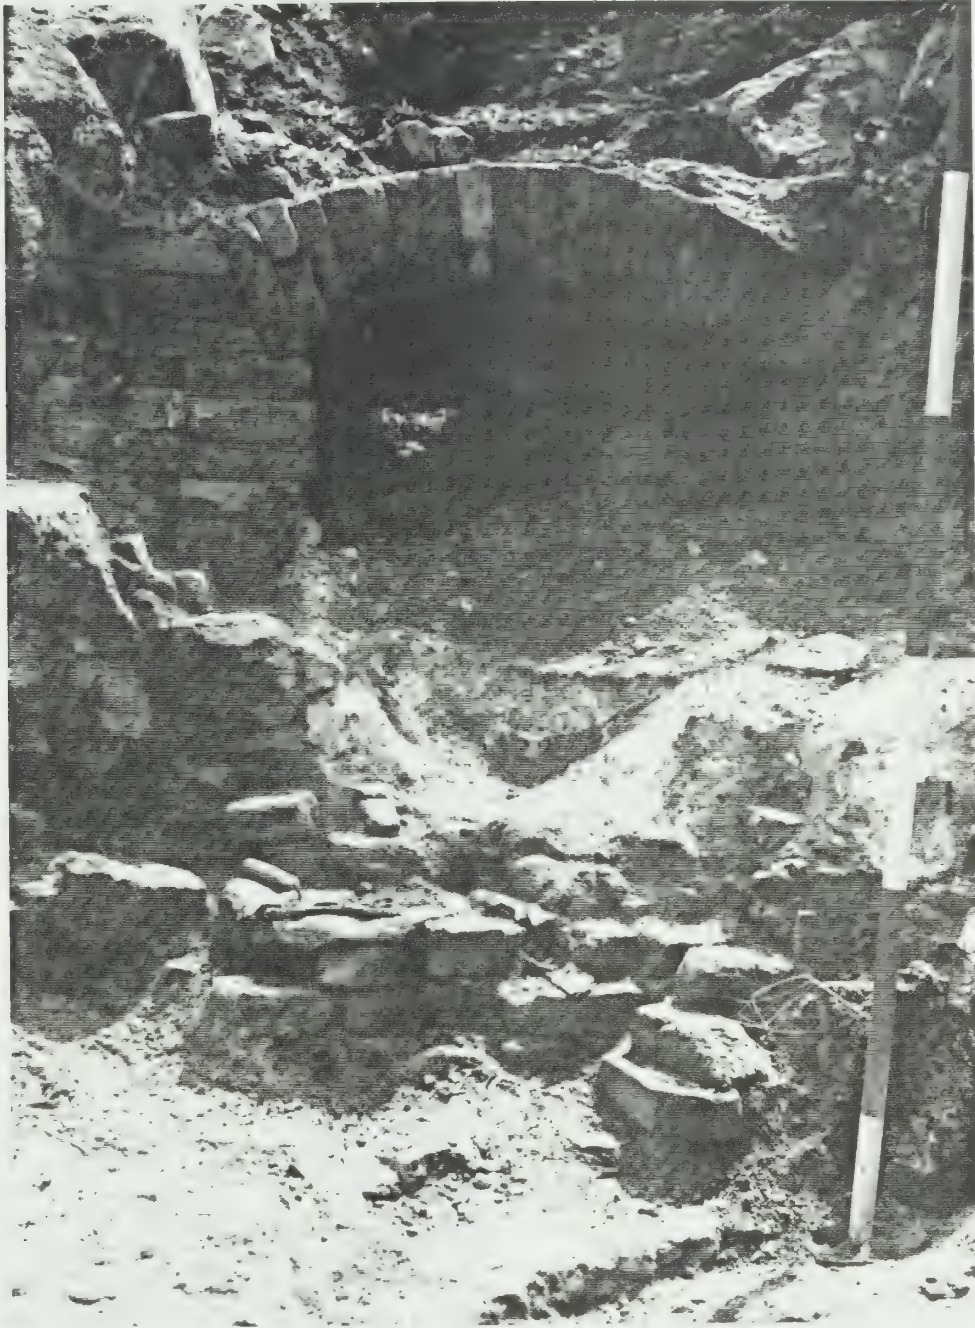
**Plate 19: Kiln One - South Furnace**

South furnace looking in from the stack, July 8, 1994. The stack lining began at approximately the location of the range rod. Assumed burner pipe is in front of the trowel handle in the lower left of the plate. A second pipe is between the trowel and range rod. Material above the brick at the bottom of the fire is limestone that has fallen into the firebox.

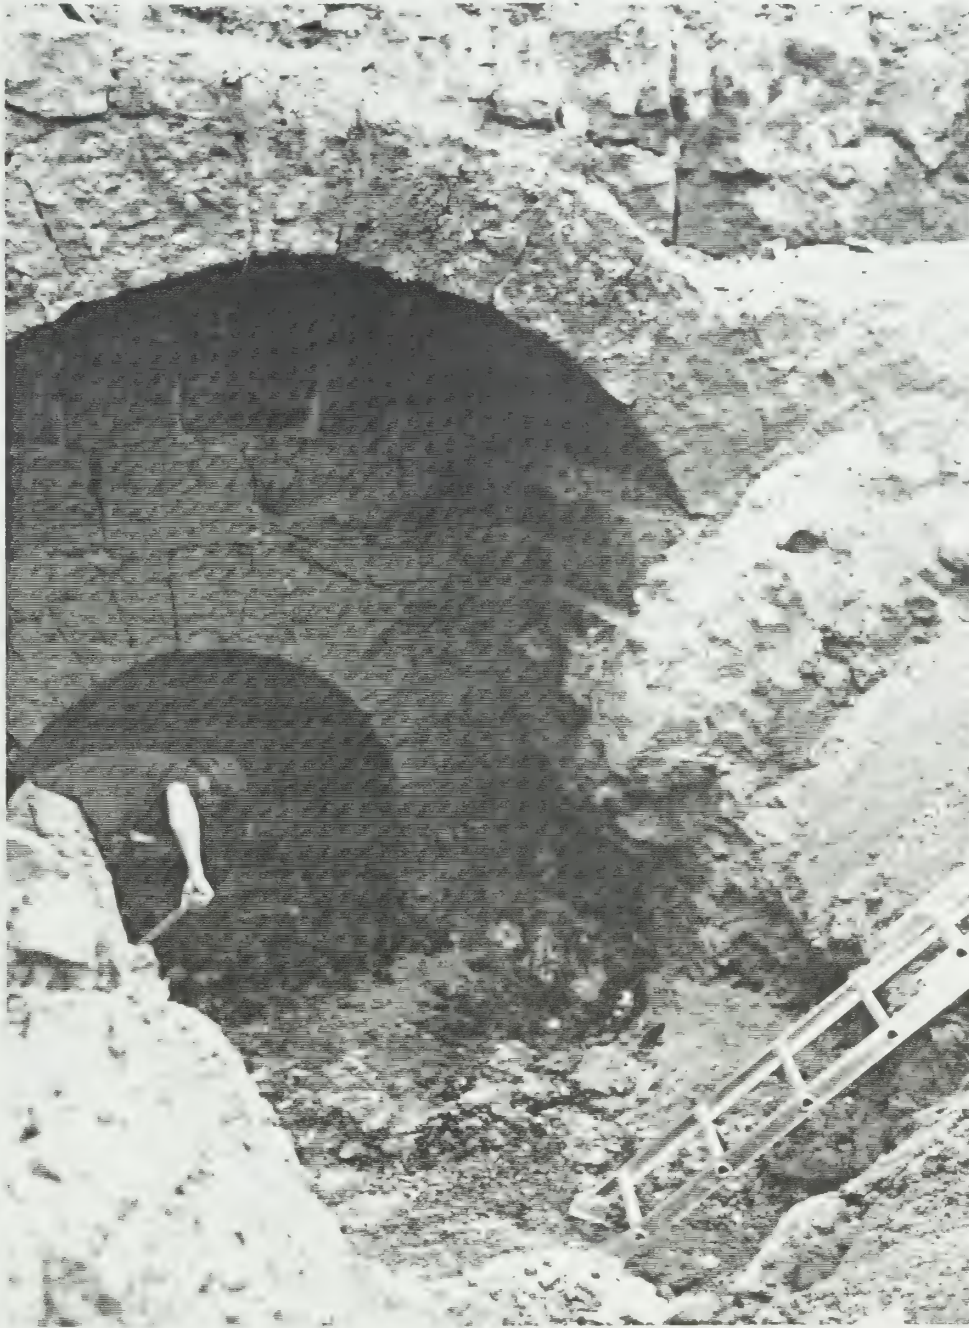
**Plate 20: Kiln One - Access Arch/Draw Hole**

Access arch and excavation of the draw hole prior to the removal of the arch, July 5, 1994. The setting of the outer arch into the bed rock can be seen.

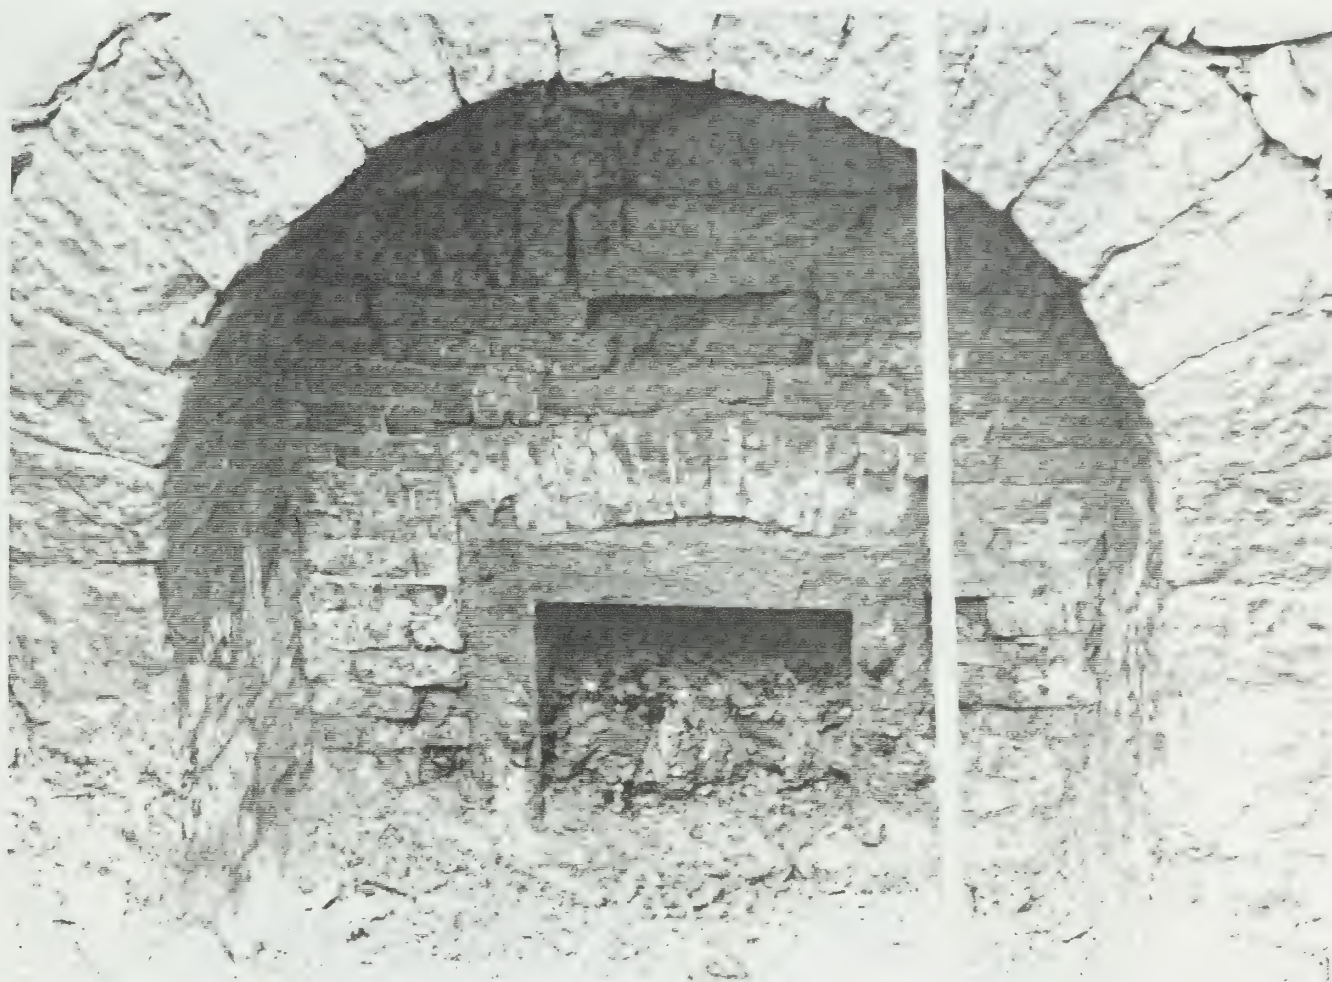
**Plate 21: Kiln One - Access Arch/Draw Hole**

Draw hole and inner access arch showing three rows of stone block on top of the brick wall surrounding the draw hole, July 5, 1994.

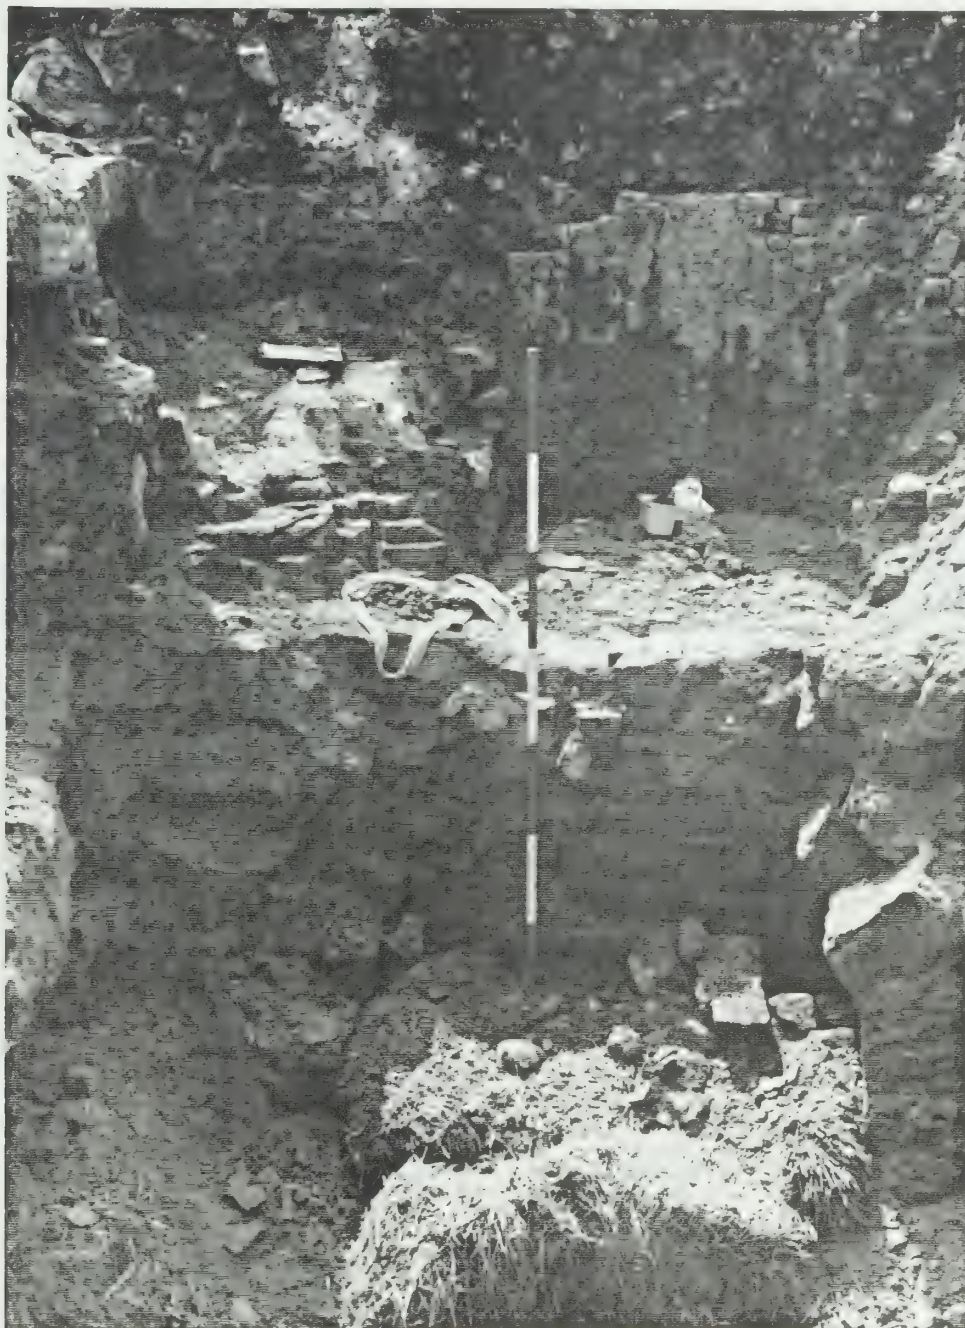
**Plate 22: Kiln One - Access Arch/Draw Hole**

Access arch after removal of the inner arch, July 8, 1994. The south furnace is on the left; stack lining rises above the range rod in the centre. The narrowness of the stack lining between the front of the kiln and the stack can be seen adjacent to the range rod.

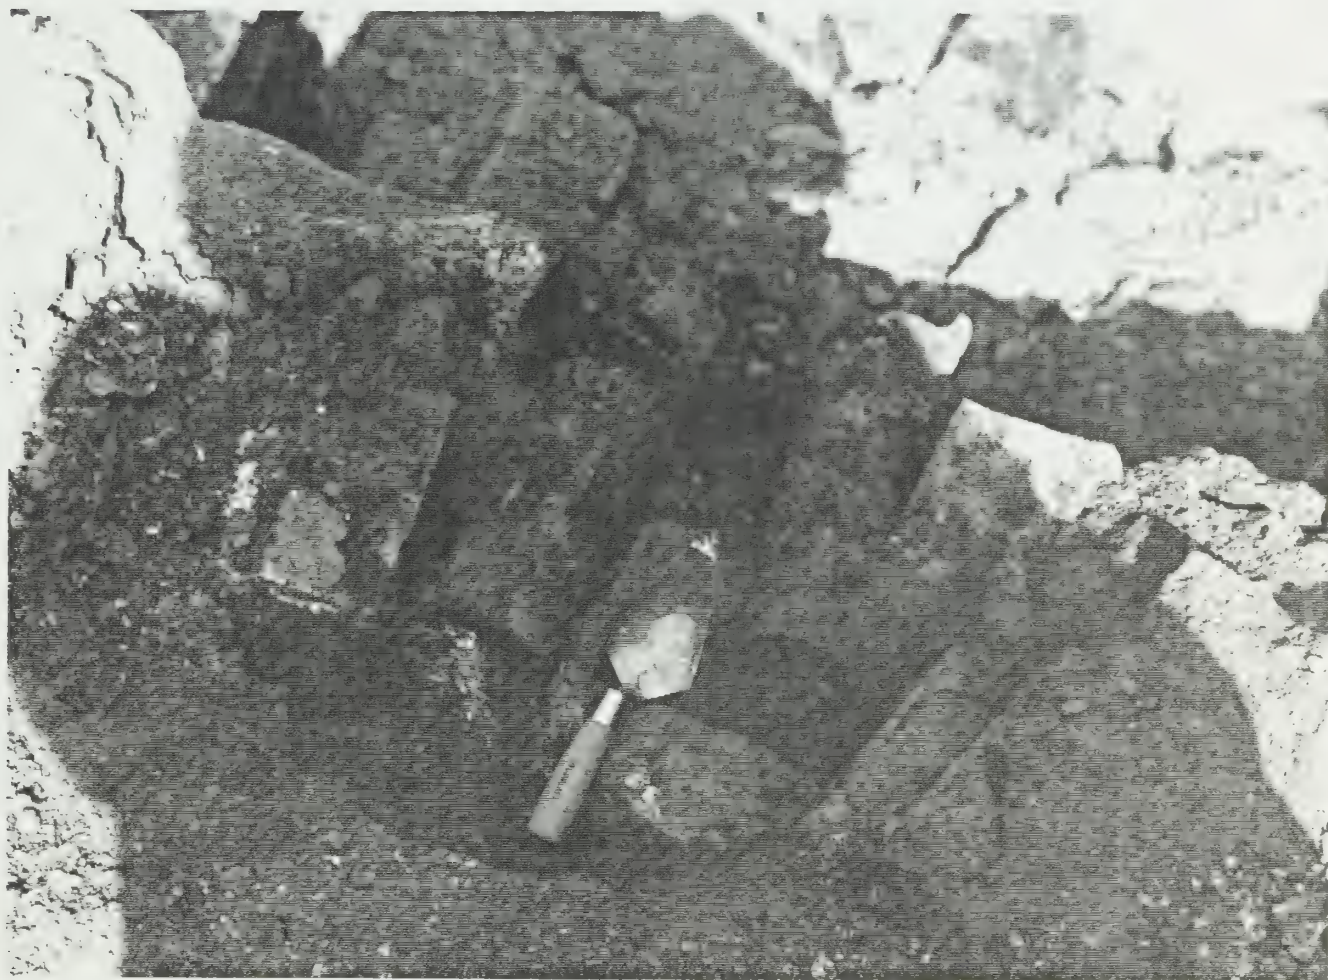
**Plate 23: Kiln One - Access Arch/Draw Hole**

Poke hole pipes directly above the draw hole, July 8, 1994. The cooler zone of the stack is at the end of the trowel handle. The brick represents the refractory lining of the cooler and the access arch wall runs diagonally across the top of the plate.

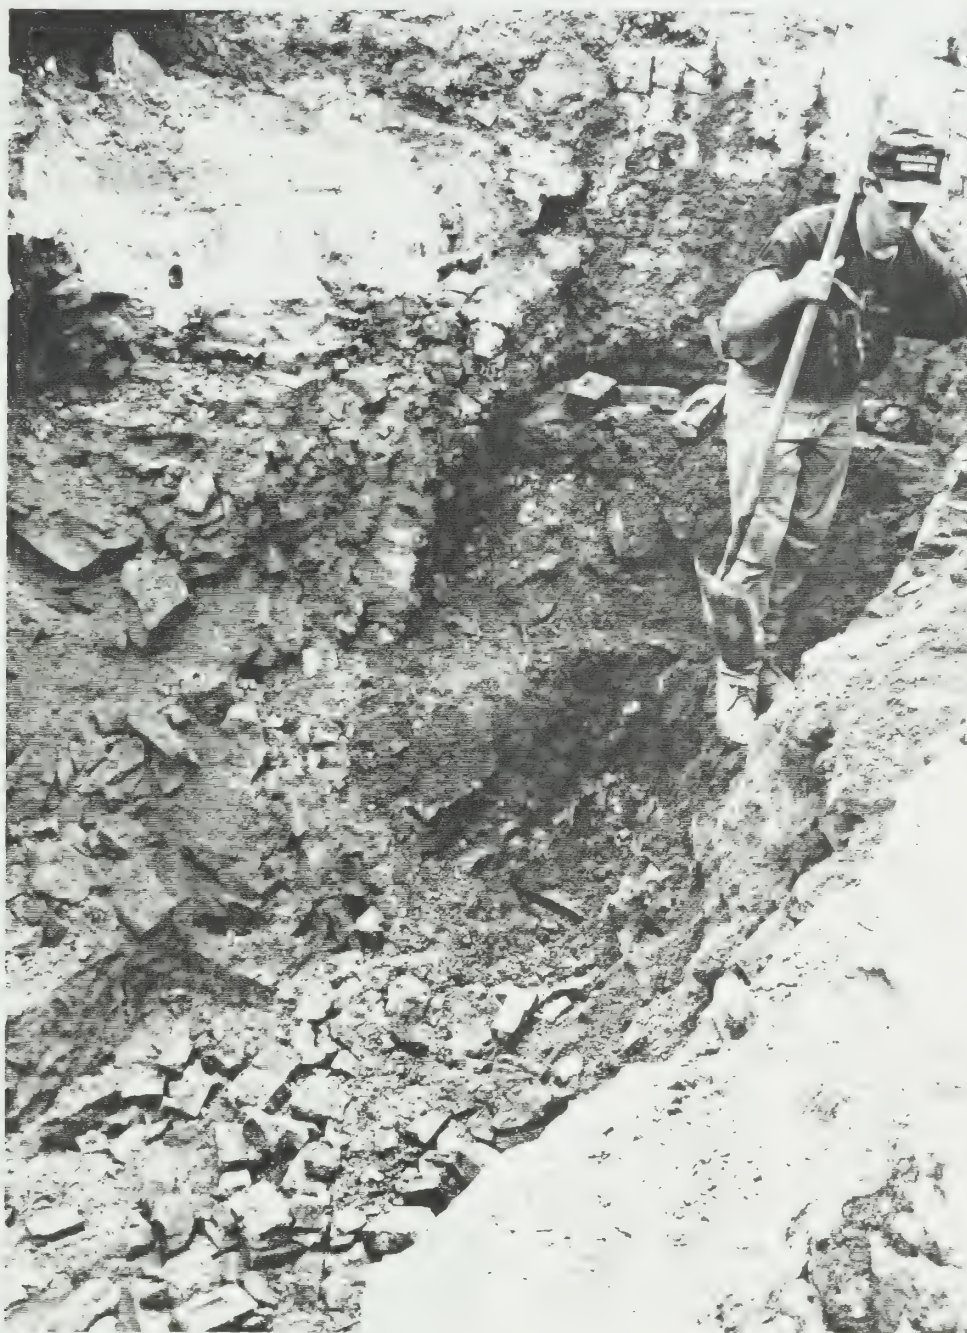
**Plate 24: Kiln One - Cooler Zone**

Cooler zone of the kiln, July 8, 1994. The white area at the upper left of the photo is lime inside the south furnace. The vertical walls of the cooler, beneath the furnace are just left of the archaeologist. A rail just above the draw hole can be seen as a dark straight line in the fill below and left of the shovel. The straight wall of the inner access arch can be seen as an L-shape at the lower left. This was the maximum extent of excavation in this area of the kiln.

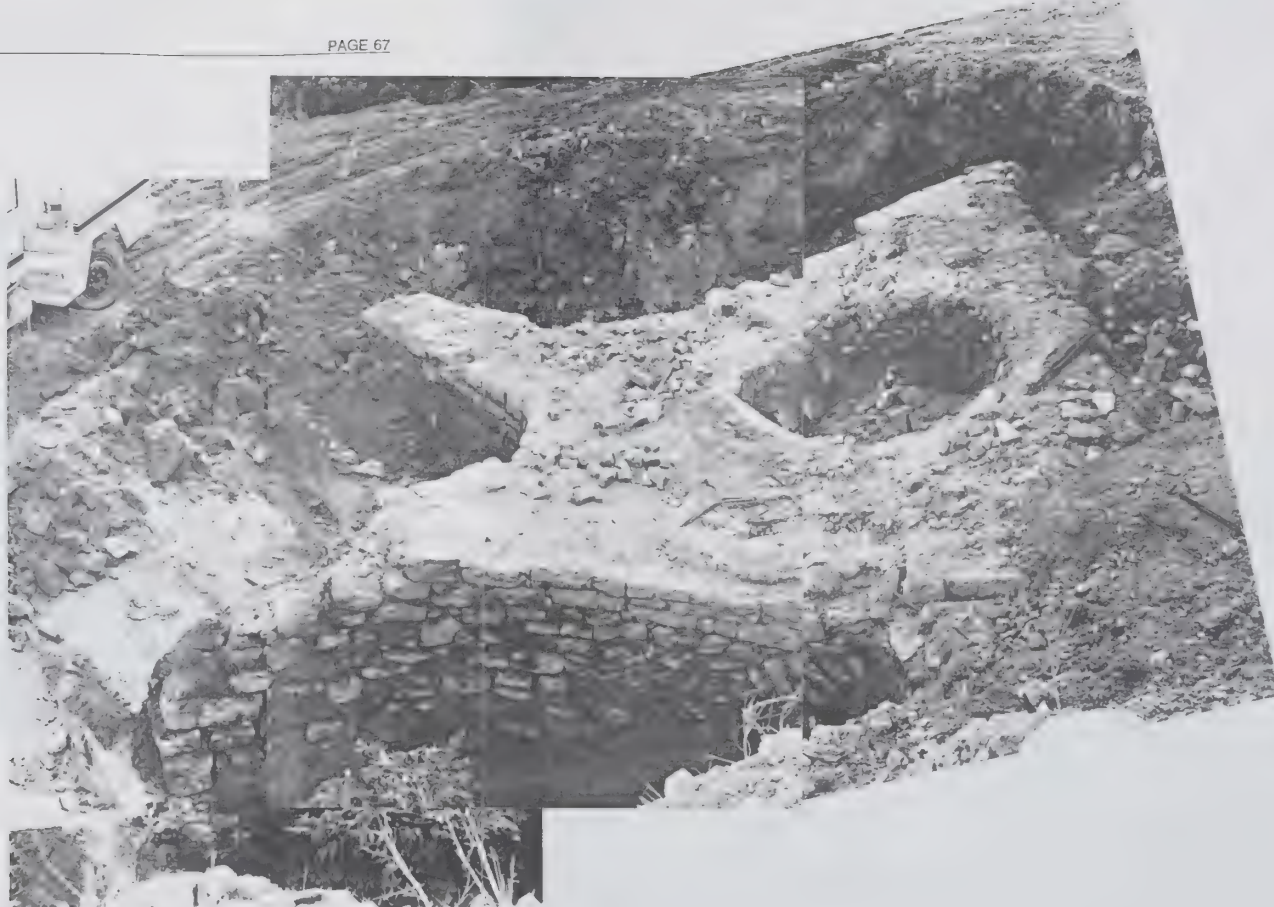
**Plate 25: Kiln Two**

Photomontage of the kiln lining generally south with the access arch on the left, retaining wall on the right and a small portion of the stone relieving arch of the north furnace just visible adjacent to the fill in the lower middle of the photo, July 12, 1994.

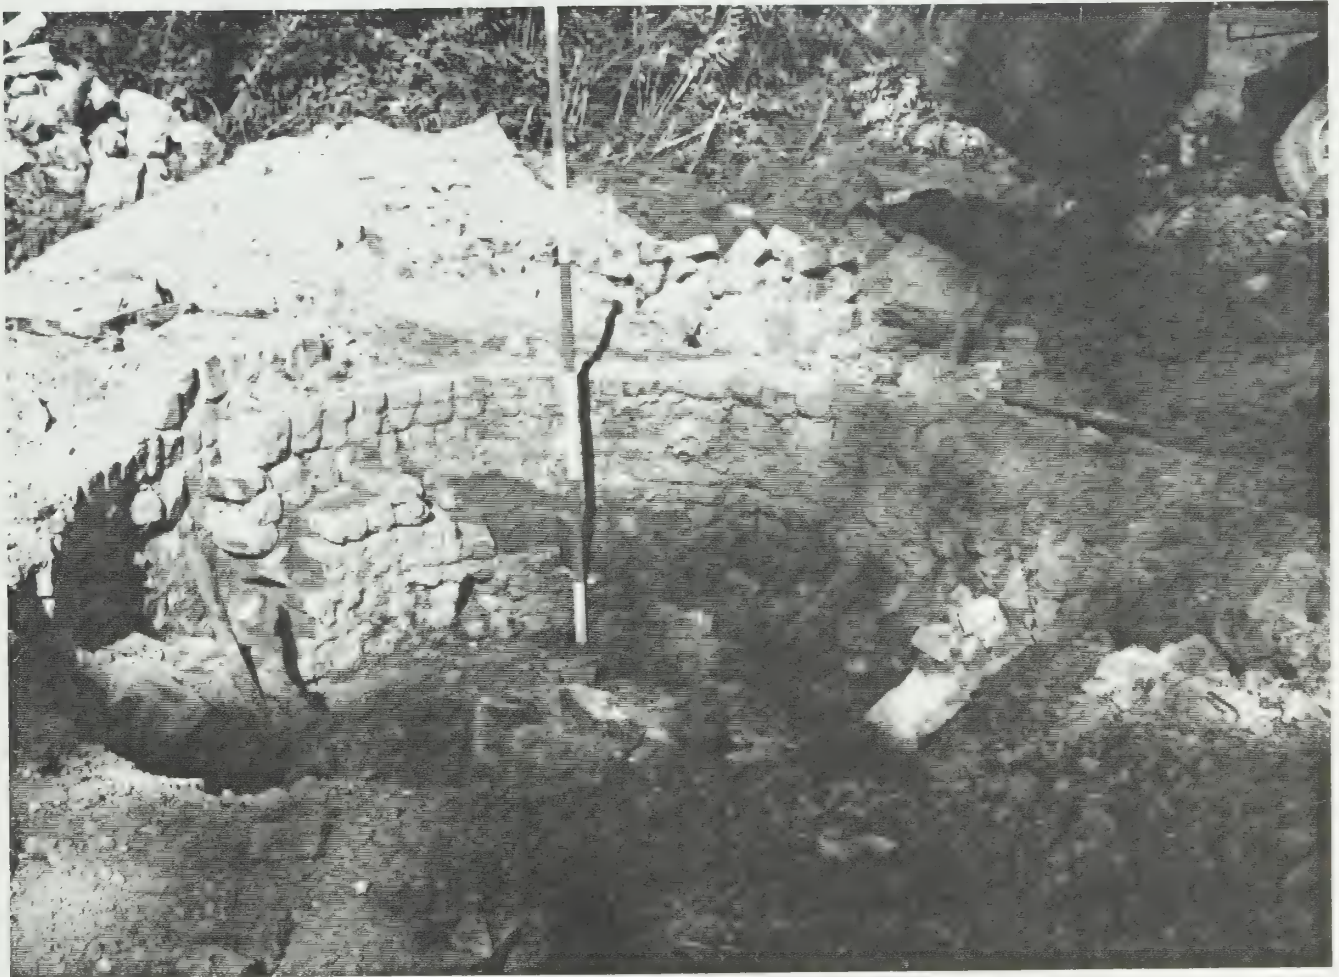
**Plate 26: Kiln Two**

Looking south across the stack showing the inner and outer layer of the refractory brick, July 11, 1994.

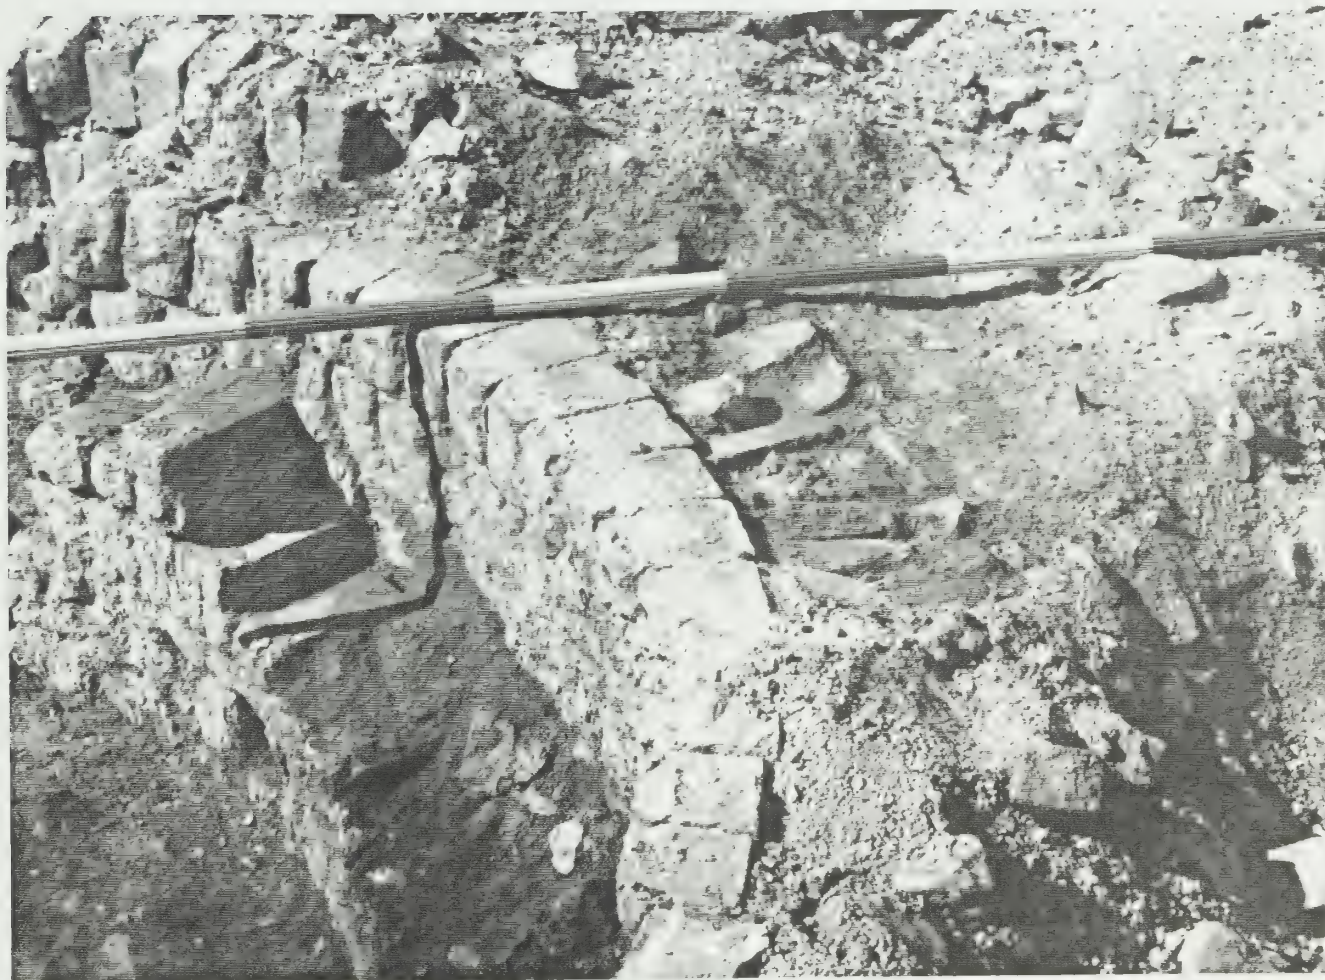
**Plate 27: Kiln Two**

Detail of the refractory brick lining, July 11, 1994. The two layers on the left had roughly equally vitrified surfaces and were not fused to each other. The secondary brick inner lining can be seen in the middle of the photo. The function of these two vitrified brick layers is unknown.

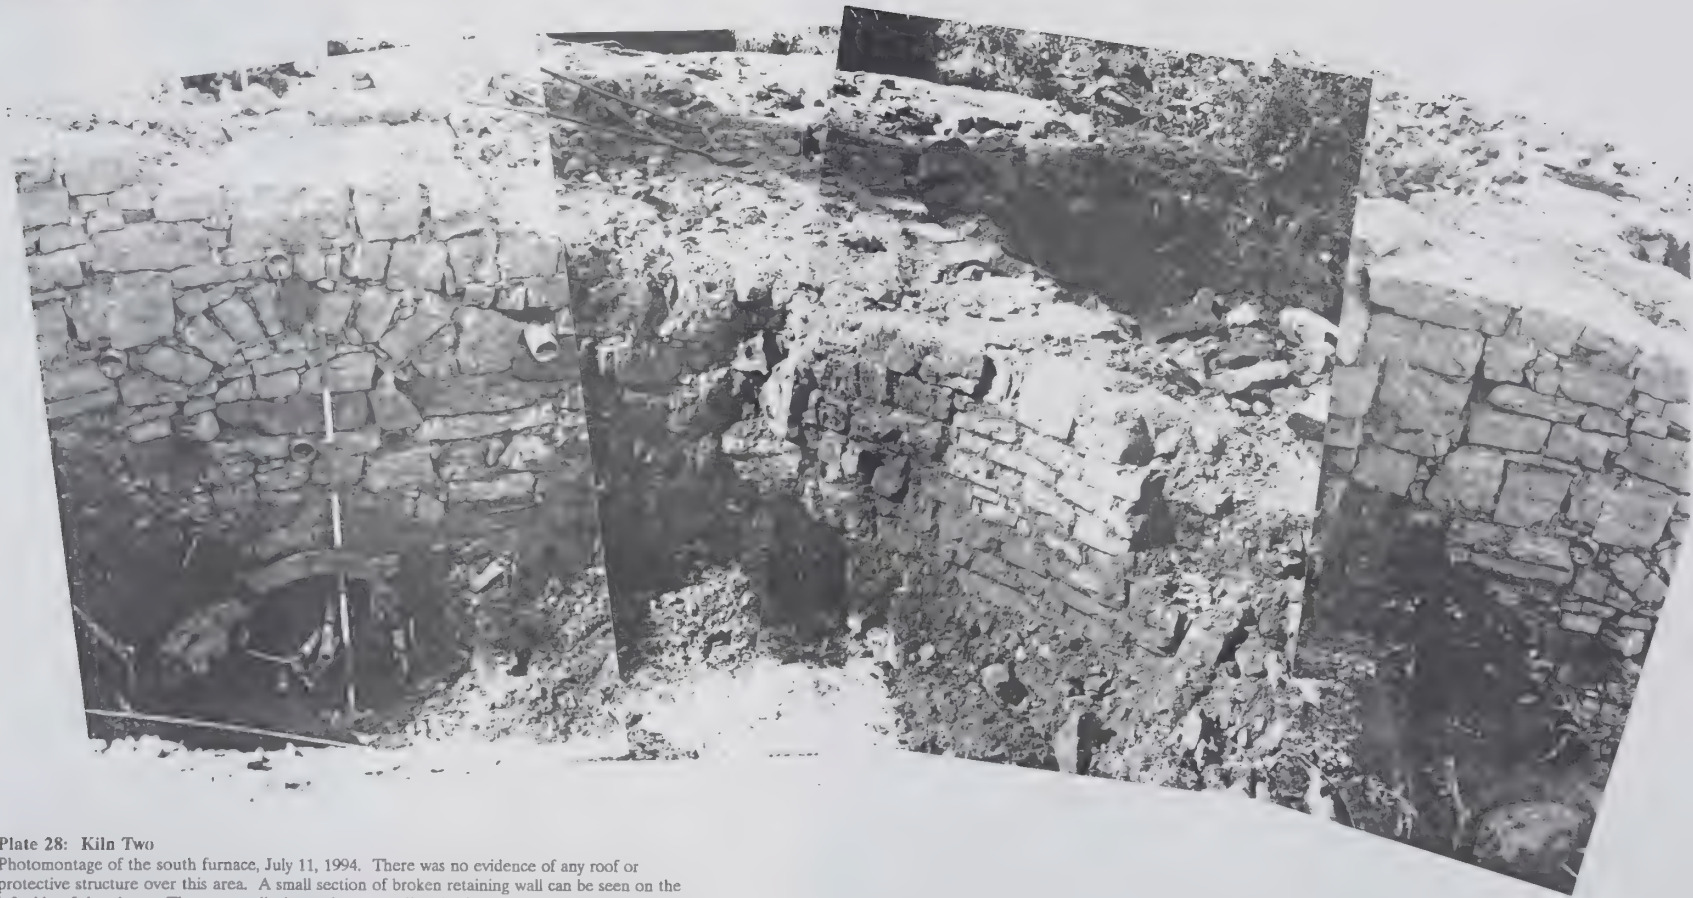
**Plate 28: Kiln Two**

Photomontage of the south furnace, July 11, 1994. There was no evidence of any roof or protective structure over this area. A small section of broken retaining wall can be seen on the left side of the photo. The stone relieving arch surrounding the furnace can also be seen. Note also the relatively small face stone compared to Kiln One [Plate 1].

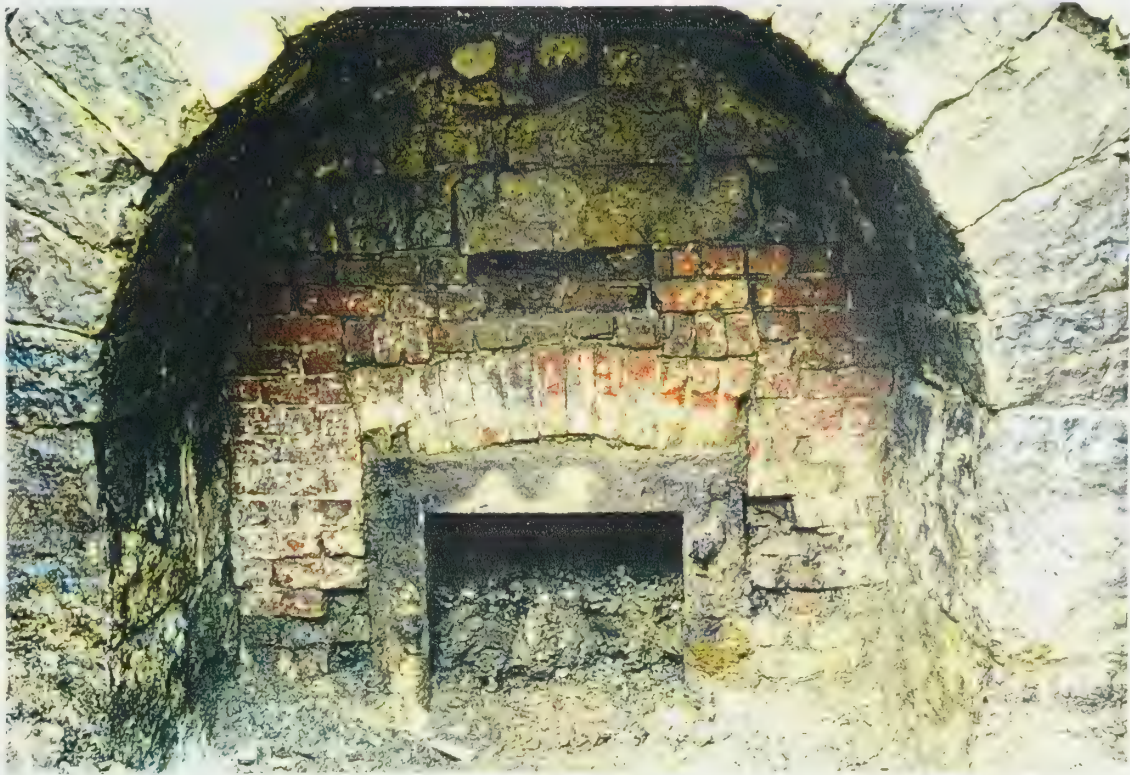
Plate 1: Area below the smaller arch. Note the condition of the bricks.
